FISHERIES DEVELOPMENT SECTION REPORT  
OF  
SEA AND FISHING TRIALS ON BOARD THE SAMOAN  
FISHERIES DIVISION'S NEW 12.2 M *SUPER ALIA*

26 April – 4 September 2000

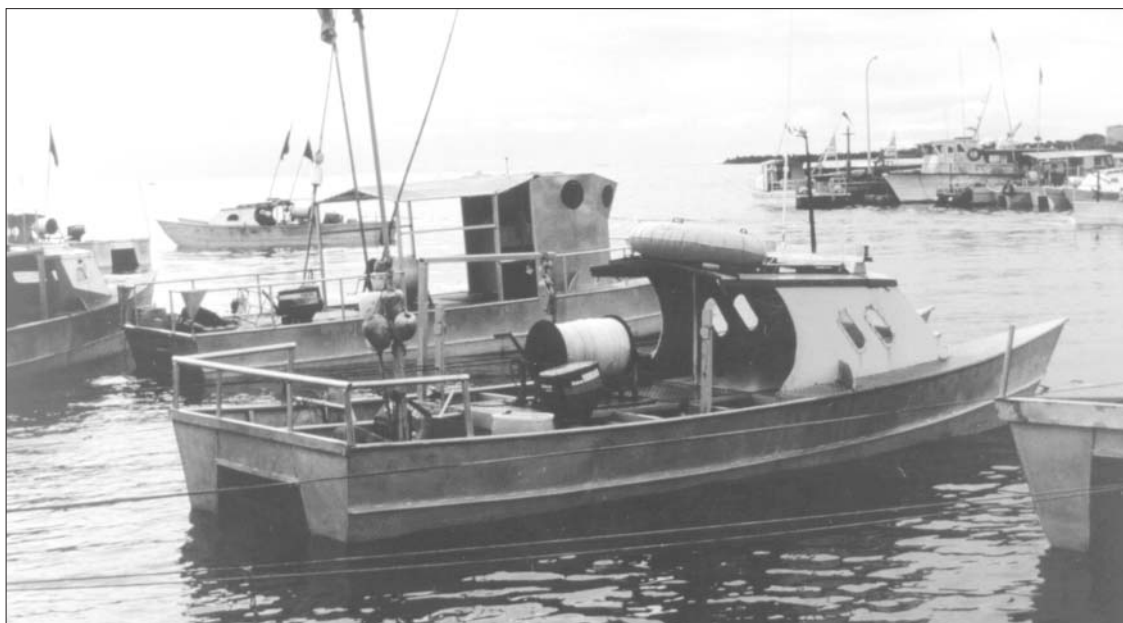
*Figure 3: Alia catamarans with tuna longline gear at anchor in Apia Harbour*

The mid-1990s saw an increase in the number of *alia* converted or built for tuna longlining. Vessel numbers increased steadily to an estimated 200 in 1999, the vast majority of which are *alia* catamarans (Figure 3). In many cases these *alia* have been modified in various ways including: increasing the height of the gunwale by 20 cm; increasing or ‘stretching’ the vessels’ length to 10.5 m; adding aluminium wheelhouses; and strengthening the outboard mounting area to take larger and more powerful outboard engines (Chapman, 1998). Larger vessels have entered the fishery as well. These include some 11.5 m aluminium catamarans, mainly imported from New Zealand, and larger, purpose-built tuna longliners in the 18–25 m range.

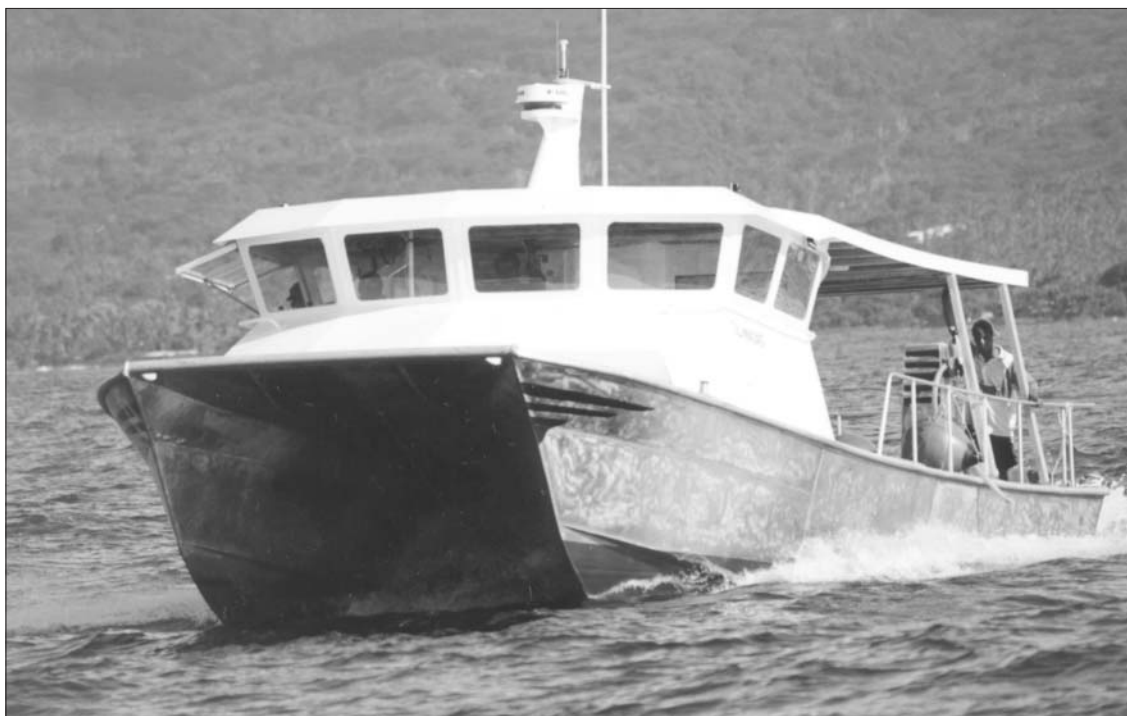
Figure 4: Project vessel F/V *Ulimasao*

F/V *Ulimasao*, (Figure 4) is a 12.2 m catamaran constructed from aluminium plate with the cabin also constructed from aluminium. The wheelhouse section in the accommodation superstructure is located on the starboard side of the vessel. The steering wheel, equipment console and power switches are all located in this area.

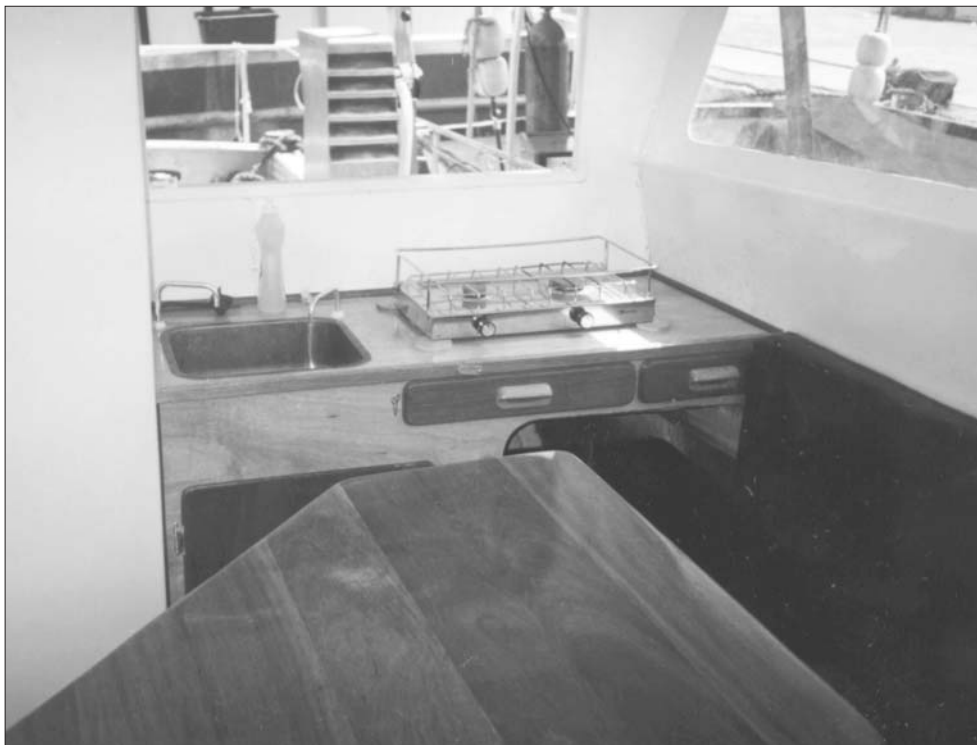
*Figure 5: Galley area on board F/V Ulimasao*

The galley contains a two-burner gas stove, a sink with foot-pumped salt water and fresh water taps, food storage cupboards and a dining table (Figure 5).

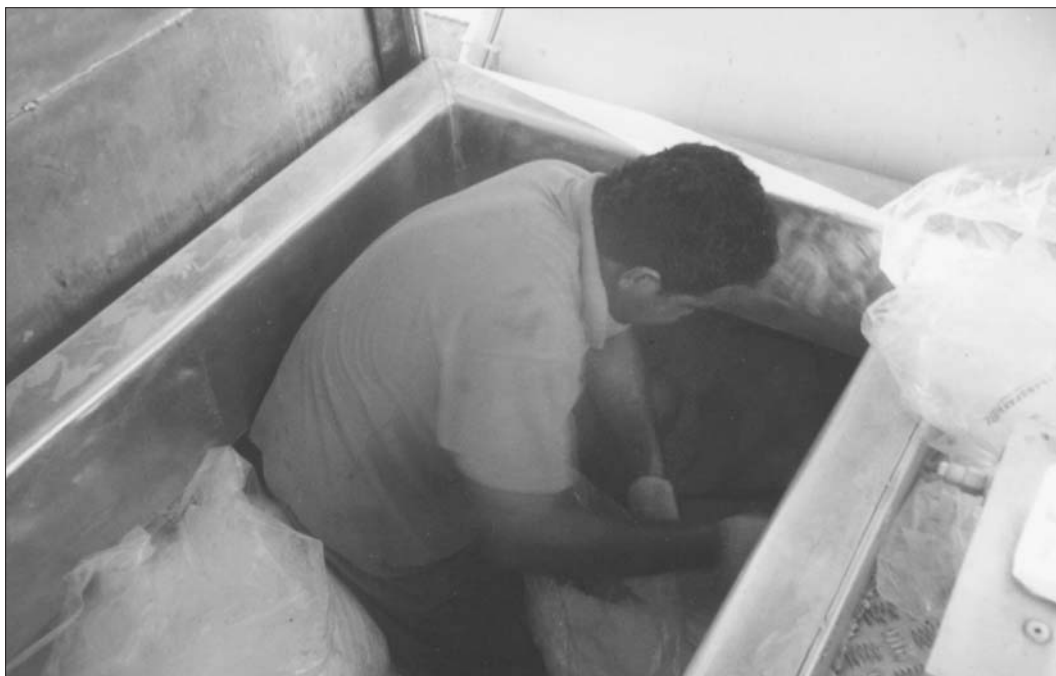
Figure 7: Fish hold with aluminium lining for ease of cleaning

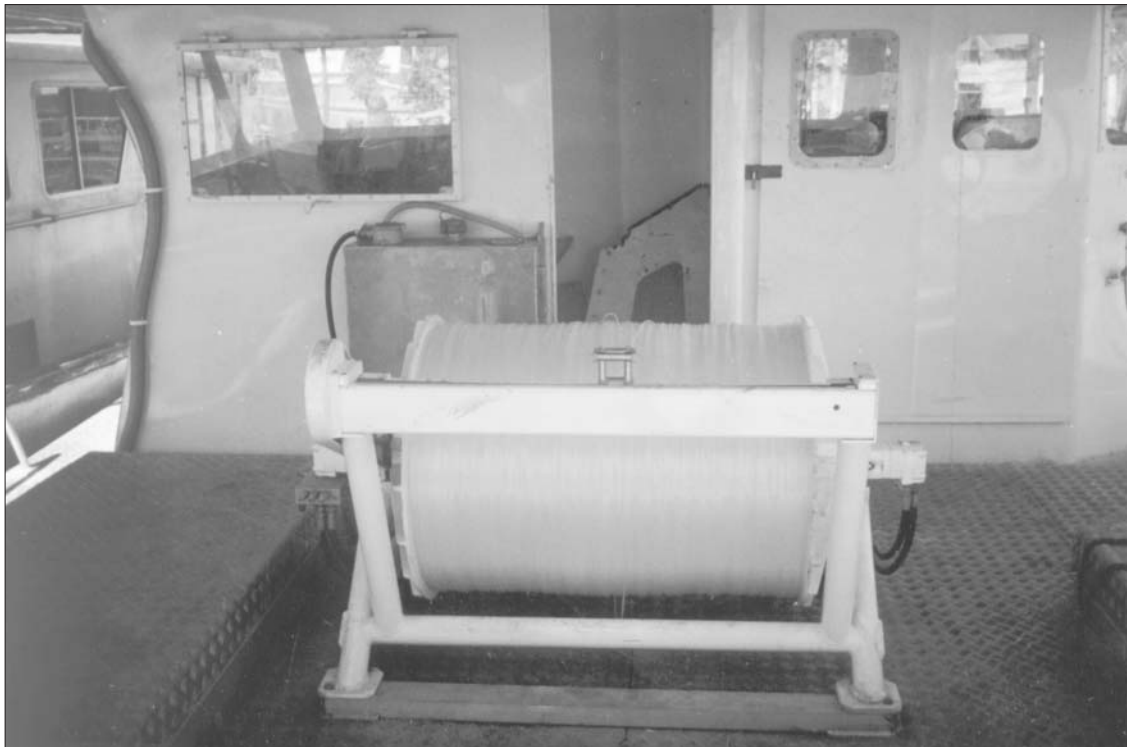
*Figure 12: Initial longline reel used on the project vessel*

The mainline reel on board F/V *Ulimasao* at the time of launching (Figure 12) was designed and built by Grant McCleary of Australian Mooring Service. This reel could hold up to 20 nm of 3.5 mm monofilament line, and was hooked up to a hydraulic system driven by a Vickers VTM Series 42 06 GPM pump. The line shooter on board was designed and manufactured by the Power Steering and Hydraulics Company of Tauranga, New Zealand.

Before sea trials were conducted, test runs were conducted in port to work out the operation of the reel. Several deficiencies were noted as follows:

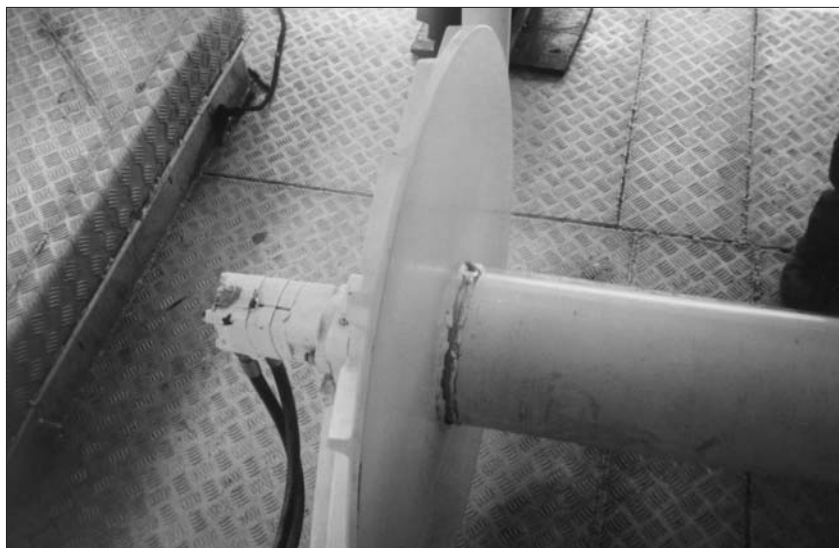
*Figure 13: Broken weld and side of mainline reel pushed out*

*Repairing and modifying the initial mainline reel while waiting for a replacement:* While hauling in the second set of the first trip, the starboard flange on the reel developed a crack right round the welded connection to the drum core. This pushed the flange outwards (Figure 13) so that it rubbed along the main frame of the reel support. Fortunately, the flange did not exert too much pressure on the support frame, and the crew were able to retrieve the rest of the mainline under hydraulic power.

Because of this defect, plans were made to repair the reel and use it until a replacement reel could be purchased and fitted. Careful consideration had to be given to the method of repair because of the work load put on a longline reel, and the amount of stress estimated to be put on the reel by a tightly wound monofilament line.

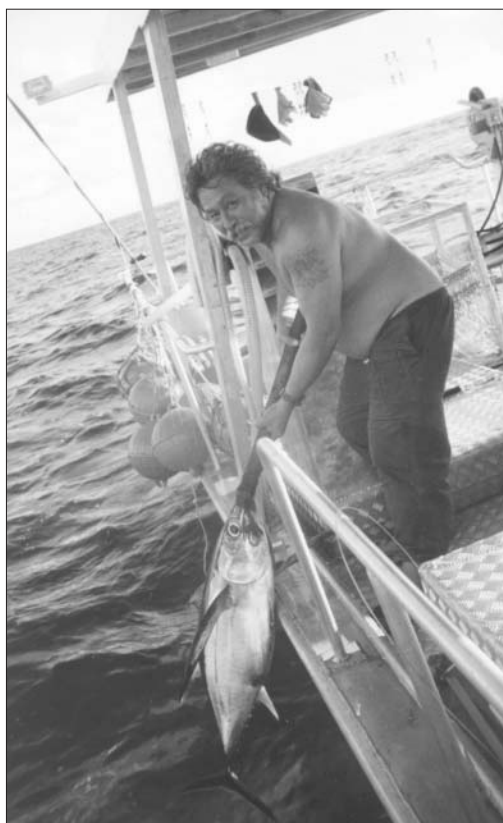
Figure 19: Fish gaffed in the head for boating

When boating a fish, the person gaffing must always ensure that the fish is gaffed through the head (Figure 19). This ensures that the flesh of the fish is kept intact allowing less chance for bacteria to enter the flesh and spoil the fish. In addition, most markets prefer fish that look whole rather than those marked in appearance.

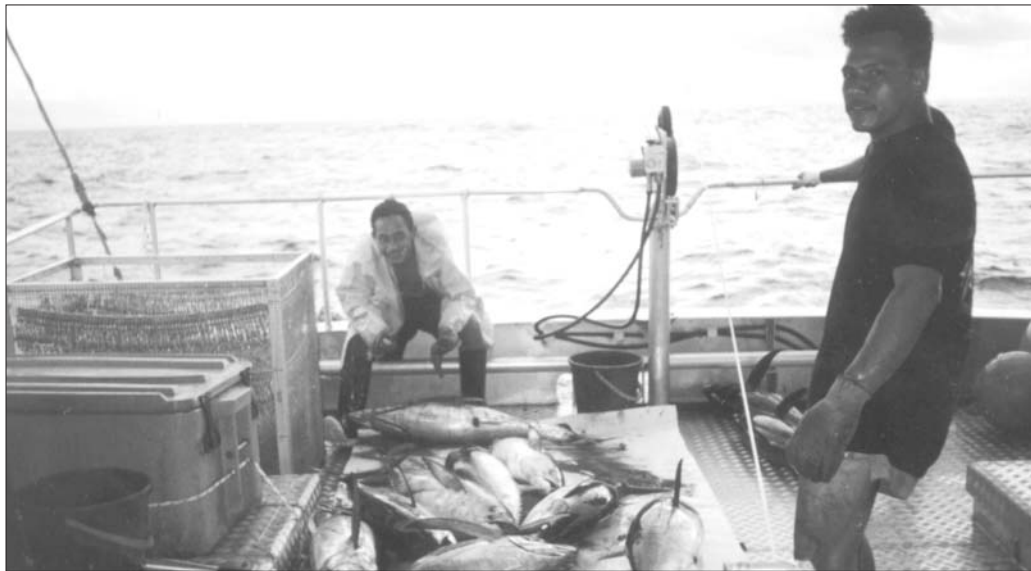
*Figure 20: Area for cleaning the catch before icing*

Next, a hole was cut around the anus and the gill attachments in the gill cavity were severed. The gills and guts were then removed completely through the gill cavity (Blanc, 1996). The gill cavity was thoroughly cleaned of blood and the fish then prepared for icing. Fish were cleaned on a rubber mat at the back of the boat (Figure 20), away from the hauling operation.

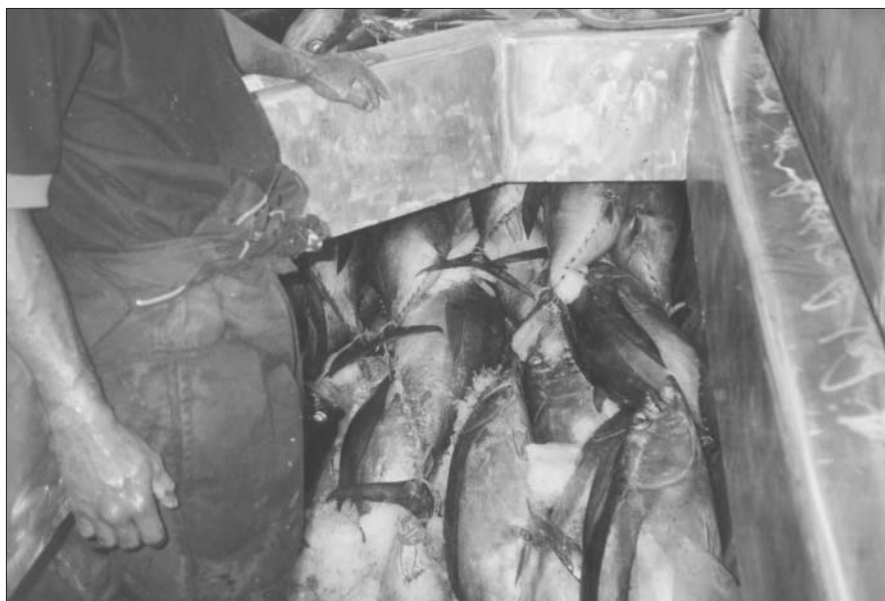
*Figure 21: Layering the catch in the fish hold for icing*

The space in the fish holds does not allow the crew much room to manoeuvre when storing fish, especially when the holds start to fill. To be able to accommodate a reasonable amount of fish in the holds, the fish had to be layered so they were touching and overlapping (Figure 21), then iced with a 150 mm thick layer over them to separate the fish layers. This method of icing fish is not ideal, although it should be sufficient for fishing trip that last up to five days. For guaranteed quality, it would be better to ice fish separately and without contact with other fish or bulkheads.
